Energy Upgrade **COMPLETED** 03/01/2014

**GOALS** Energy Efficiency, Water Efficiency  
**SOLUTIONS** Air Seal, Insulation, Ventilation,

135 Van Ness, Santa Cruz, CA 95060

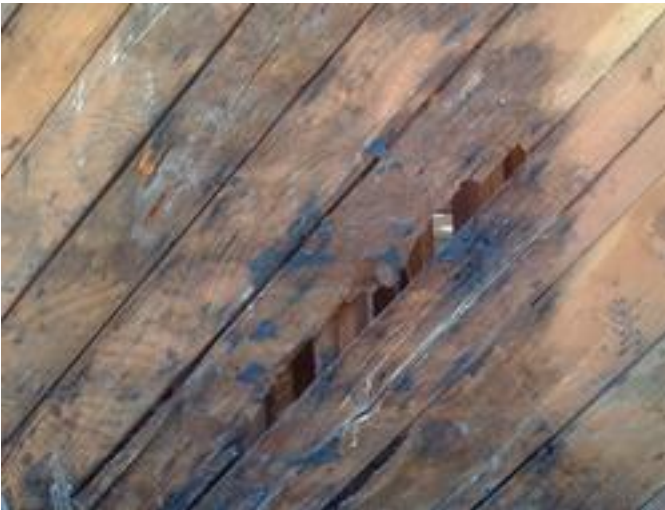
Exterior walls moisture damage

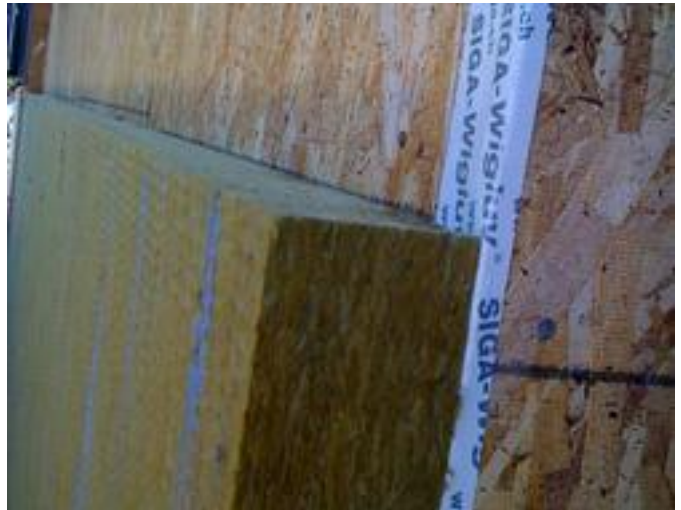
Exterior walls, sealed & insulated

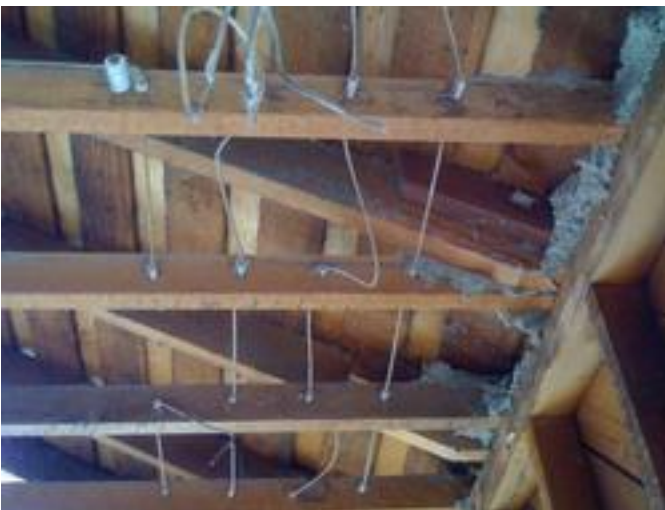
Attic: knob & tube, no insulation

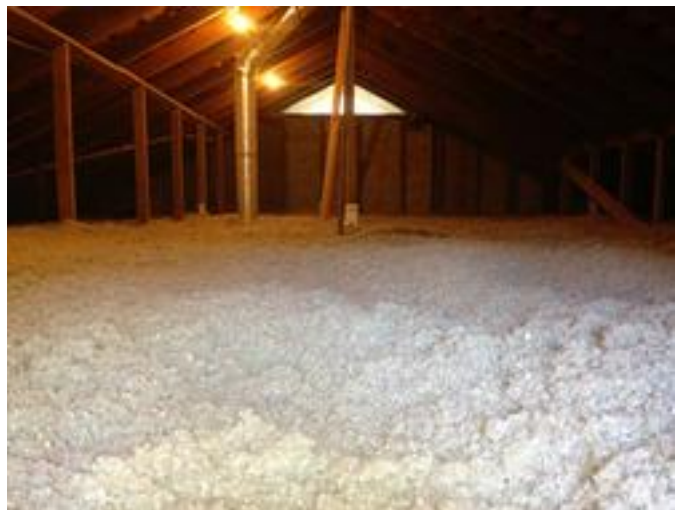
Attic: R 80
